Bill Recycler

# BR2300

Installation Guide

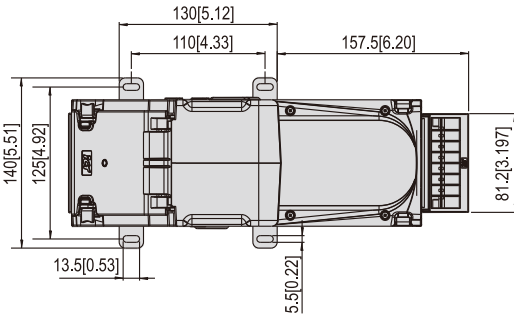
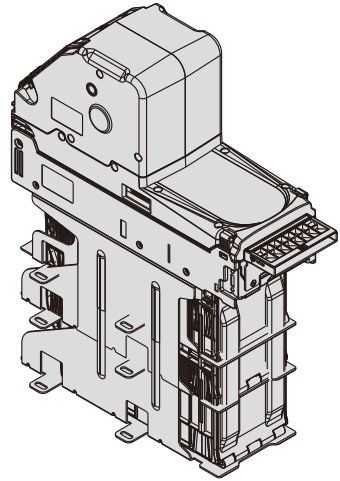
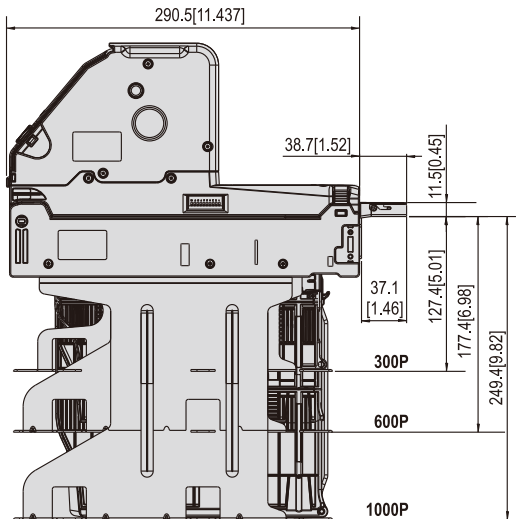
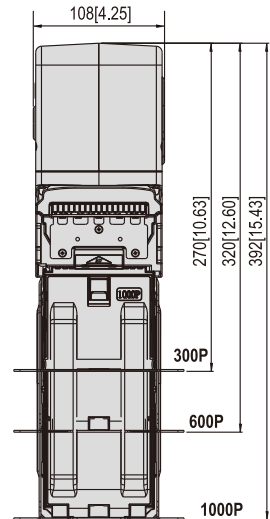
4 FIG.01

Unit : mm [inch]

Bezel Style

Rectangle Bezel

Part Number: 3ZMB-FAC50000

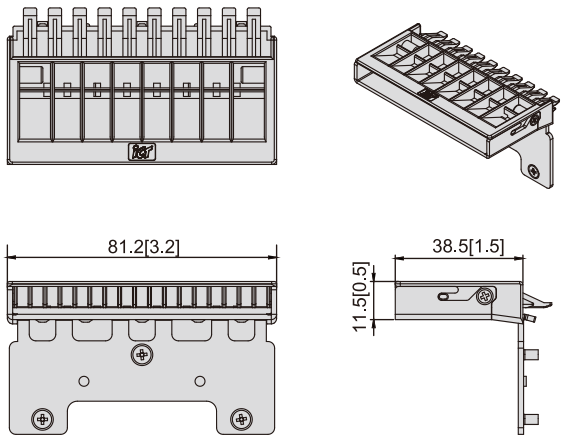
Unit : mm [inch]  
4 FIG.02

Metal Short Bezel

Part Number: 3ZMB-FAC60000

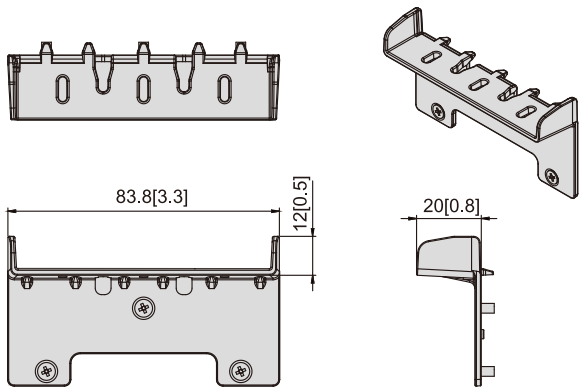
Unit : mm [inch]  
4 FIG.03

## Plastic Short Bezel

Part Number: 3ZMB-FAC61000

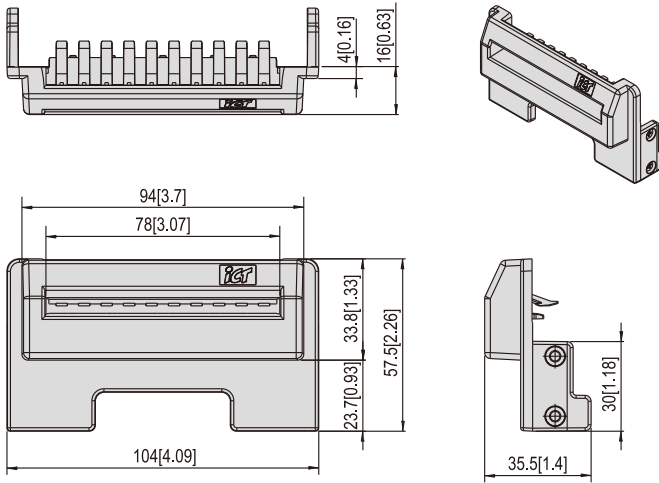
4 FIG.04

Unit : mm [inch]

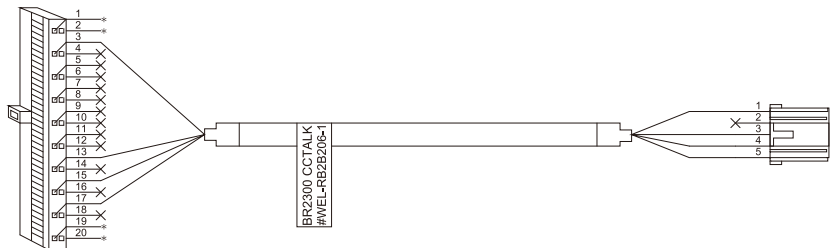
WEL-RB2B206-1

PIN 3- BLACK.....GND  
PIN 13- YELLOW.....DATA  
PIN 15- WHITE.....POWER GND  
PIN 17- RED.....DC POWER INPUT

PIN 1- RED.....DC POWER INPUT  
PIN 3- YELLOW.....DATA  
PIN 4- BLACK.....GND  
PIN 5- WHITE.....POWER GND

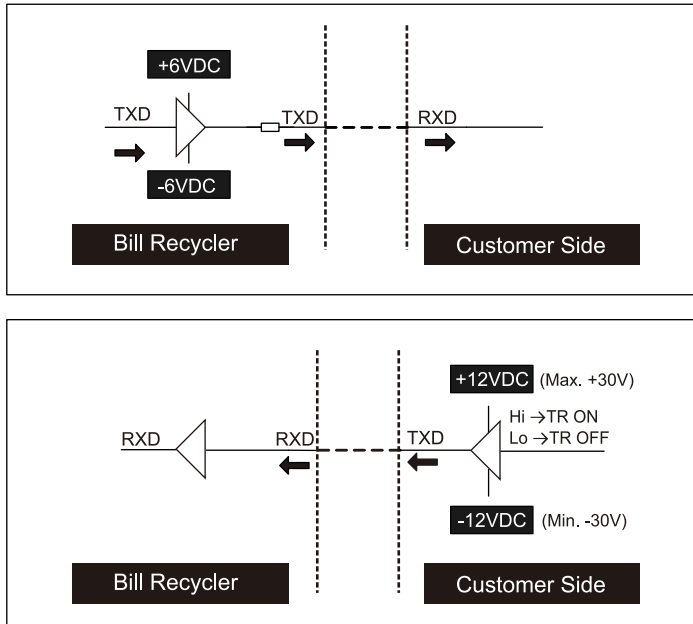
5-1-1 FIG.01

## RS232 Interface

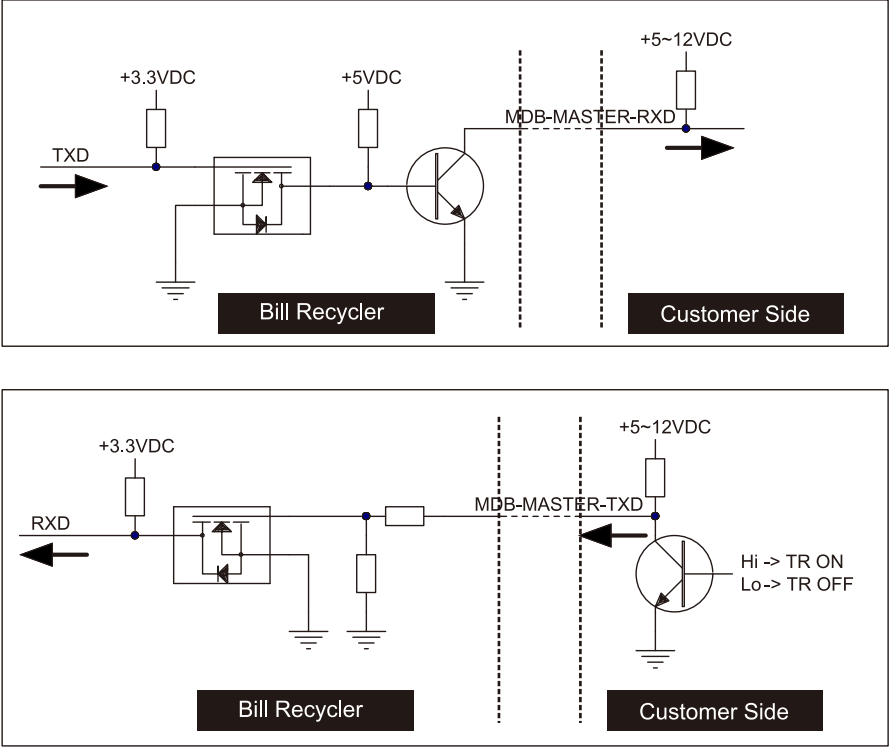
5-1-1 FIG.02

MDB Interface(To VMC).

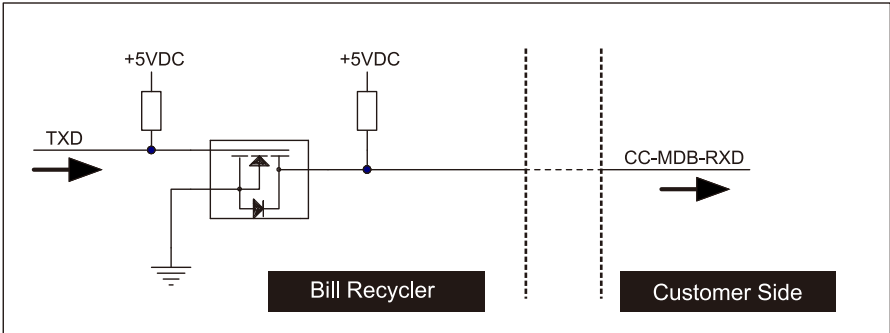
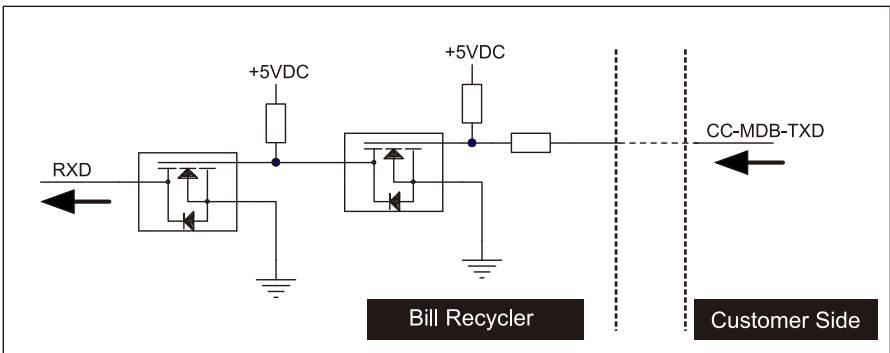
5-1-1 FIG.03

## MDB Interface(To Coin Changer).

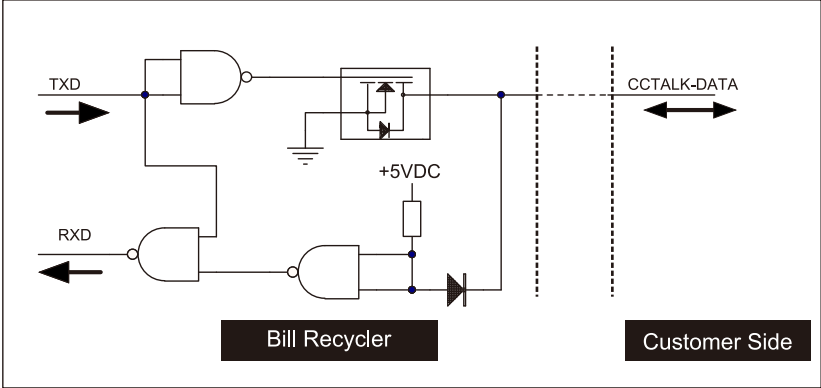
5-1-1 FIG.04

ccTalk interface

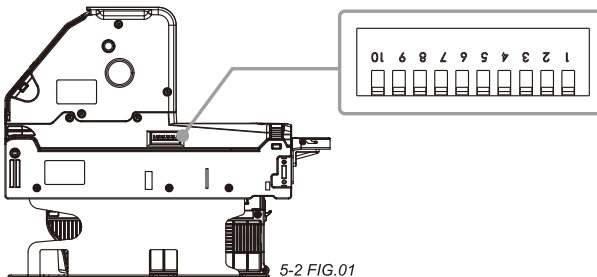
5-2 FIG.01

There's a serial DIP switches which is located on the side of BR2300. According to different currencies or interfaces which are used by users, DIP switch settings could be varied to fit users' need.

Please refer to "BR2300 DIP Switch Setting" Guide in the package for more detail.

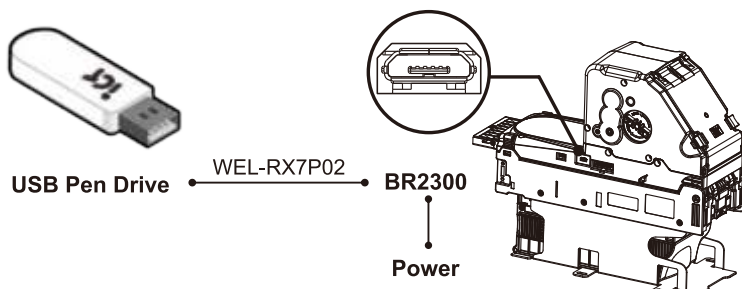
Turn off BR2300, plug the USB Flash Disk into the USB connector on the BR2300 with USB extension cable and then turn on the BR2300.

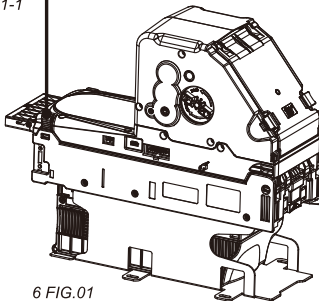
6 FIG.01-1

1. Turn bill recycle off.
2. Press the buttons on the side of BR2300 cover and lift the unit .
3. Use a soft, dry cloth, or towel to clean the bill path and sensors.

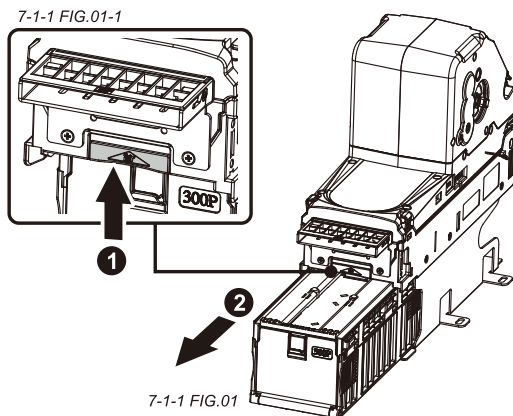
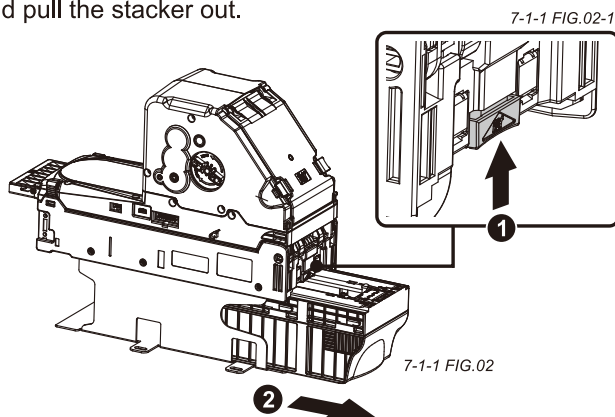
### 7-1-1. Removing stacker jammed banknote.

To remove the stacker from front or rear, you only need to press the white button and pull the stacker out.

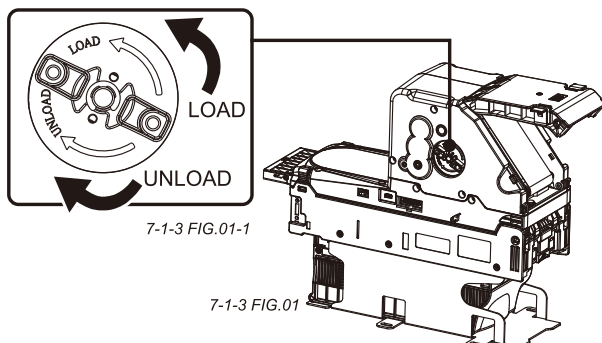
### 7-1-3. Rotate the wheel to remove the jammed banknote.

Having the incident of banknote jam in the recycler, be sure to take out all the notes in it so that in the next operating act, the counting of banknotes could remain correct in the recycler.
